## Australian Speleological Federation Inc. Karst Conservation Fund:

# Honeycomb Cave Entrance Stabilisation Project

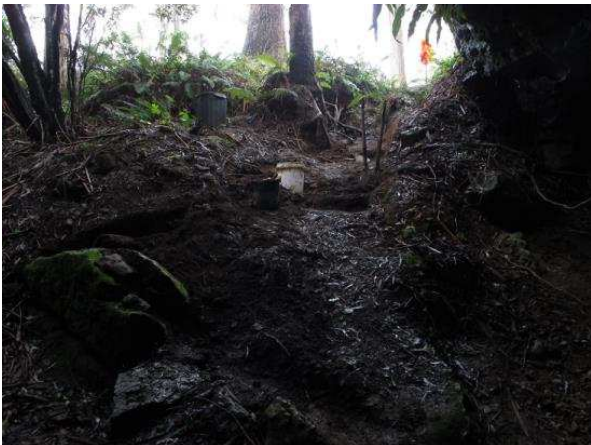
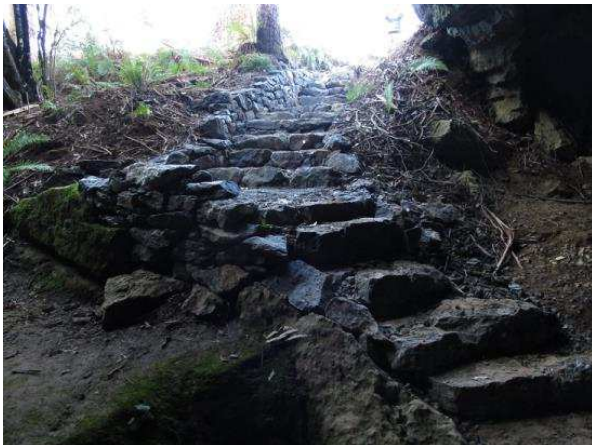
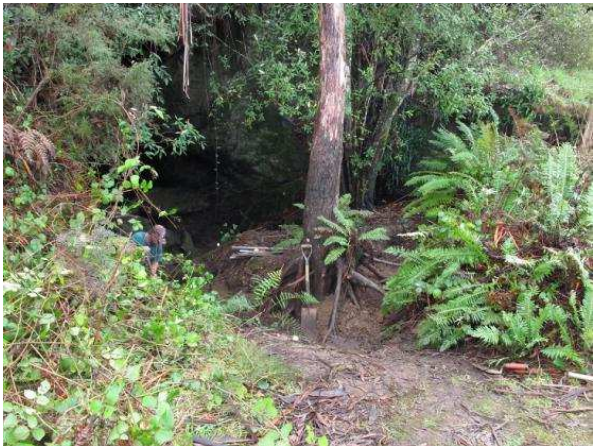
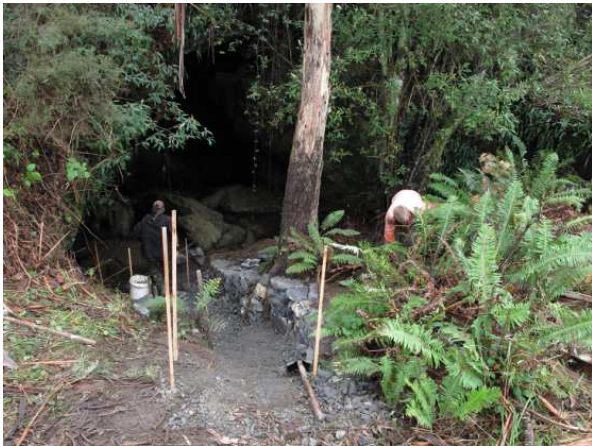
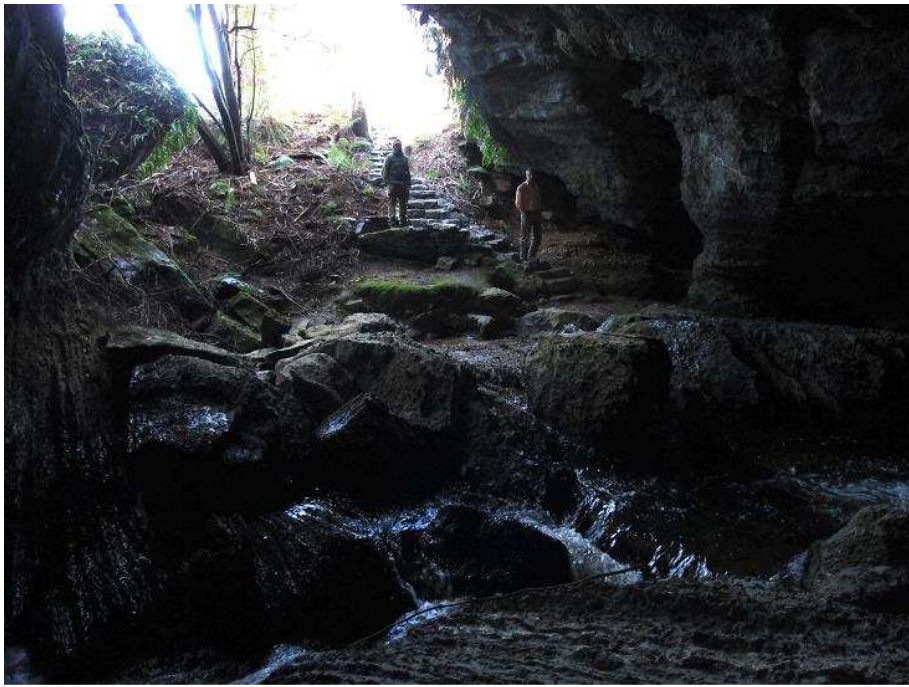
Before and after photos of the Honeycomb Cave Entrance Stabilisation Project.

The works involved construction of a set of Limestone steps and a combined small, integral 1meter x 1 meter viewing landing also in Limestone. The steps now safely lead visitors to a viewing landing in order to view some of the caves features. Coupled with this, the stabilisation of the earth bank has once again restored the natural dynamic equilibrium of this seasonally inundated bank. The provision of a more managed cave entrance is expected to cut down on visitors wandering into the cave at multiple areas and causing unnecessary trafficking damage elsewhere.
